Bartlomiej Sawicki, Antoine Bassil, Eugen Bruhwiler, Xavier Chapeleau,
Dominique Leduc

Bartlomiej Sawicki, Antoine Bassil, Eugen Bruhwiler, Xavier Chapeleau, Dominique Leduc. Detection and Measurement of Matrix Discontinuities in UHPFRC by Means of Distributed Fiber Optics Sensing. *Sensors*, 2020, 20 (14), pp.1-20. 10.3390/s20143883 . hal-02949204

Detection and Measurement of Matrix Discontinuities in UHPFRC by Means of Distributed Fiber Optics Sensing

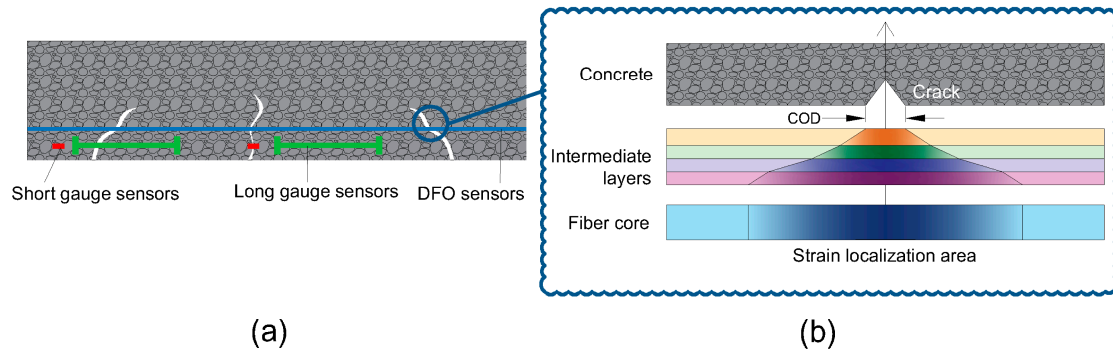
Figure 1. Crack detection in concrete using Distributed Fiber Optics sensing techniques; (a) comparison to traditional sensors, (b) strain transferring between layers.

The DFOs techniques can be used not only to measure strains but also to detect, localize and measure cracks of small openings. DFO sensors allow achieving of an accurate, reliable and quasi real-time crack detection and characterization in concrete structures. They contributed to the detection and localization of cracks in the massive structures, showing supremacy over the short and long gauge sensors (Figure 1a). Actually, any type of discontinuity in the host material, like a crack, can cause a strain localization propagating through the optical fiber layers up to the core of the optical fiber (Figure 1b).

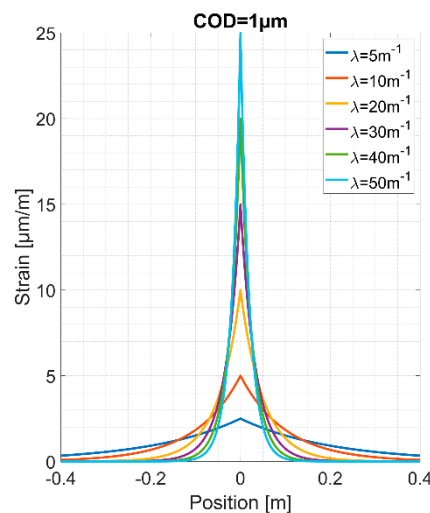
Figure 2. The spatial distribution form of the crack-induced strains $\varepsilon_{crack}(z)$ for different strain lag parameter λ values.

The strain lag parameter λ is crucial for the sensing of cracks. As this value increases, the crack-induced strains $\varepsilon_{crack}(z)$ figure higher peaks at the crack location, and thus, the exponential part covers a narrower zone over the optical fiber length, as shown in Figure 2. Thanks to this, the capacity of detecting and localizing discontinuities increases.

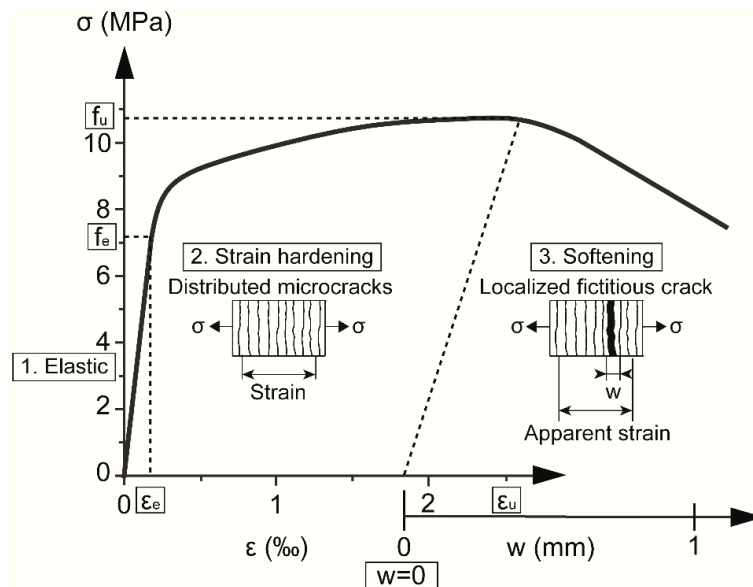
Figure 3. UHPFRC behavior under tension.

After the elasticity limit (f_e, ε_e) is reached, discontinuities in the matrix start to appear and the material enters the strain-hardening phase. The openings of these fine, distributed microcracks (hairline cracks) are smaller than 50 μm and their spacing can vary from 2 to 30 mm [43–45]. They are not detrimental from a durability point of view [46,47] and are impossible to see with the naked eye. These microcracks can be, however, measured using appropriate instrumentation. From the macroscopic point of view, the material can be considered as continuous, with strain-hardening quasi-linear behavior and reduced stiffness [48]. However, after unloading, the residual strain remains in the material.

When the maximum tensile resistance f_u is reached, the material enters the softening phase. One or more neighboring microcracks start rapidly growing, eventually reaching openings above 50 μm . This localized discontinuity is bridged by multiple fibers carrying the tensile stress. It is called a fictitious crack, contrary to the real crack which cannot transfer the stress [49]. Since the stress transfer capability in this critical zone is reduced, the overall stress in the area decreases. The localized fictitious crack is growing, while the strain and stress around it decrease. The location of the fictitious crack depends on the distribution of fibers [44,45,50,51]. Since this fictitious crack leads eventually to the

failure of structural elements, it is called the critical crack as well. With the gradual opening of the fictitious crack, the measured deformation increases, leading to fast growth of the apparent strain. Importantly, it is not the real strain of the material anymore due to the fictitious crack localized between the reference measurement points.

The fictitious crack grows until opening of half of the steel fiber length, in the present case $l_f/2 = 6.5$ mm [44] and the resistance of the material decreases. After the fibers are pulled out, no more stress transfer is possible and the real crack is formed.

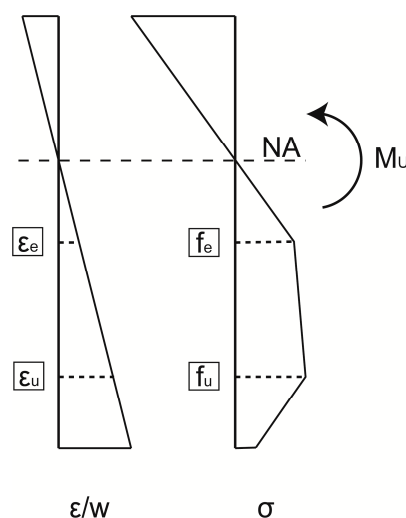
Figure 4. Schematic distribution of stresses and strains in UHPFRC at the critical section of R-UHPFRC beam under the ultimate bending moment.

In the case of a structural R-UHPFRC (Reinforced UHPFRC) element under bending action, the tensile behavior of UHPFRC has important influence on the overall response. Each of the three stages are present under the maximum bending moment in the critical section, where the fictitious crack forms. Under the assumption that the cross-sections remain plain, the distribution of stress along the height of the beam is nonlinear due to nonlinearity of the constitutive law of UHPFRC, as presented schematically in Figure 4. The proportion between parts in elastic, strain-hardening and softening regimes depends on geometry of the element [44].

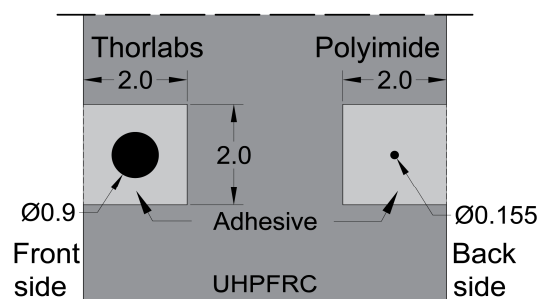
Figure 6. Scheme of installation method of DFO sensors in UHPFRC; dimensions in mm.

The beam was instrumented with extensometers; photogrammetry DIC by means of two 20 MP cameras; DFO sensors (Figure 5). The fiber optics sensors for distributed strain sensing were installed in three lines at each face of the beam—40, 90 and 190 mm from the bottom of the beam. As shown in Figure 6, the DFO sensors were glued in a 2×2 mm groove on the UHPFRC surface using a bicomponent epoxy adhesive (Araldite 2014-2). On the front side of the beam, the SMF-28 Thorlabs® fiber was glued, with an external diameter of $\varnothing 900 \mu\text{m}$ and elastomer tubing. On the back side of the beam, the Luna® High-Definition Polyimide fiber was used, with an external diameter of $\varnothing 155 \mu\text{m}$. The DIC measurement zone spanned 35 cm from the midspan symmetrically, and over the whole height of the beam on the front side. The extensometers of 100 mm measurement base were glued on the back side of the beam, at the level of each DFO measurement line. Additionally, three LVDTs with the common measurement base were vertically installed on the back side of the beam, at midspan and over the supports. The mean vertical displacement over the supports is subtracted from the vertical displacement at midspan to obtain the deflection of the beam. The resistance force was measured by the load cell of the actuator.

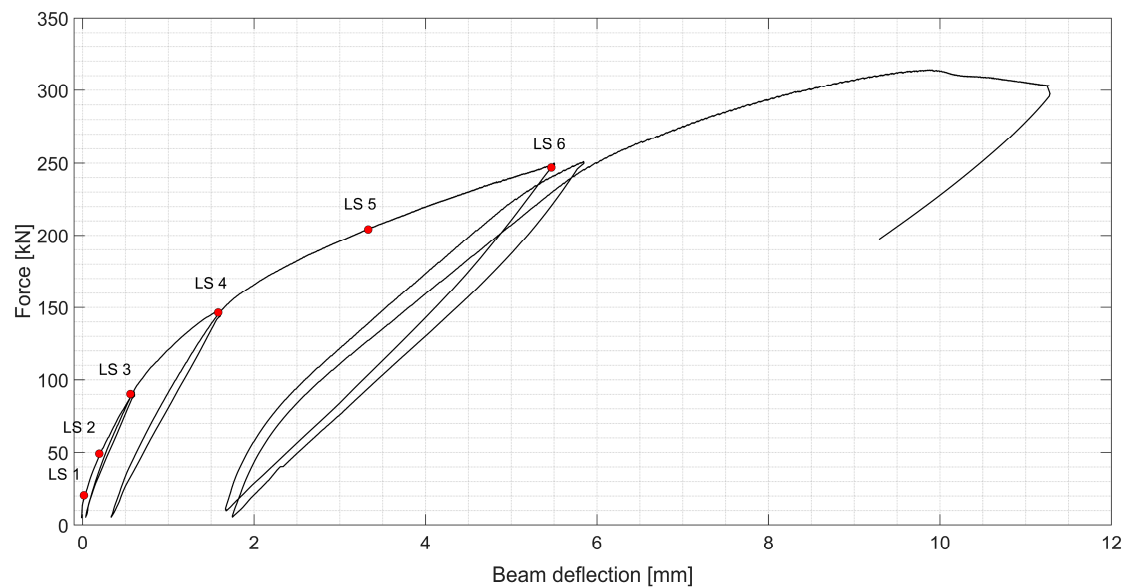
Figure 7. Load–deflection curve of the R-UHPFRC beam during quasi-static test, total jack force presented with consecutive load steps (LS) marked.

The force–midspan deflection curve is presented in Figure 7. Several loading–unloading cycles were executed at different stages of the test. The goal was to visualize the influence of residual strain of the UHPFRC in the strain-hardening domain after unloading on the global response of the beam. Thanks to this, a gradual degradation of material can easily be observed. The load steps (LS) were chosen arbitrarily to discuss the state of material in detail.

The first linear part of the curve is very short. This is due to the material at the bottom of the beam entering the strain-hardening regime relatively soon. As the zone where UHPFRC is in the strain-hardening regime is growing, gradual reduction in material stiffness, and thus, beam rigidity occurs, effecting nonlinearity of the force–deflection curve. The residual deflection in the unloading cycle comes from the fact that this part of cross-section contains discontinuities (microcracks $< 50 \mu\text{m}$) or, in the further stages, the fictitious crack ($> 50 \mu\text{m}$) is present. Both types of discontinuities transmit the tensile stresses thanks to fibers, but do not close completely while unloaded. Finally, when the beam resistance is maximum with the force of 313 kN, gradual degradation with a rise in deflection continues as the localized fictitious cracks propagate and the longitudinal rebar is yielding.

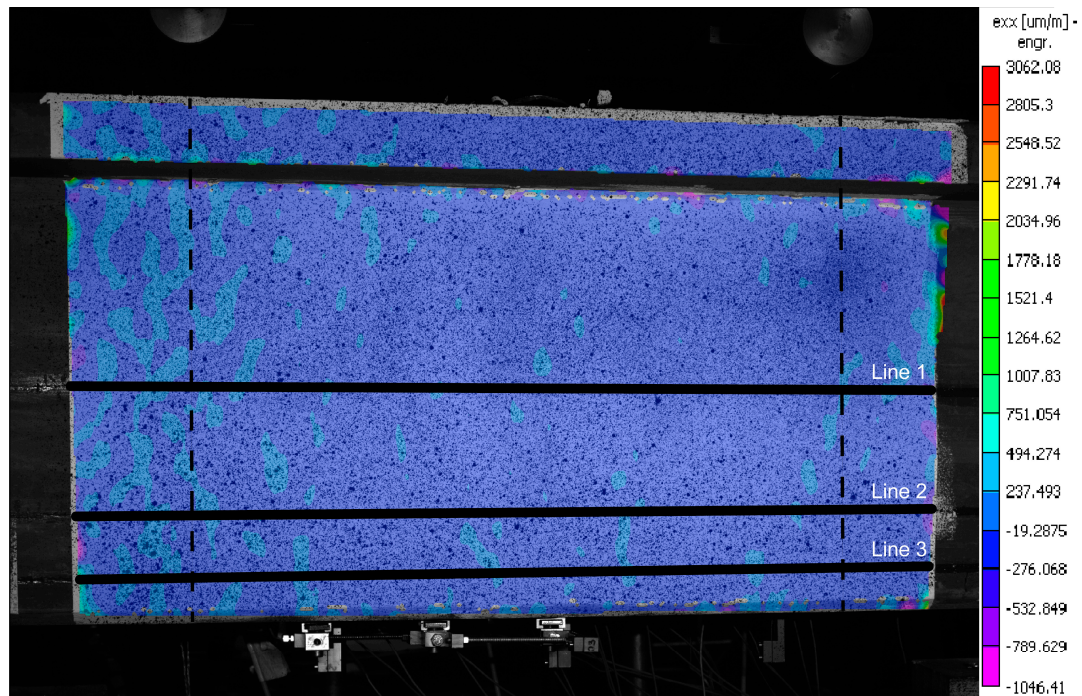
Figure 8. DIC measurement at unloaded state with virtual measurement lines noted; the constant bending moment zone is marked with dashed lines.

The unloaded state of the beam is presented in Figure 8. The measurement noise for DIC is mostly at the level of $\pm 100 \mu\epsilon$, with local peaks of $-300 \mu\epsilon$. The strain noise is not only due to the quality of the cameras and nonuniformity of light, but mostly from the variation of size and distribution of speckles.

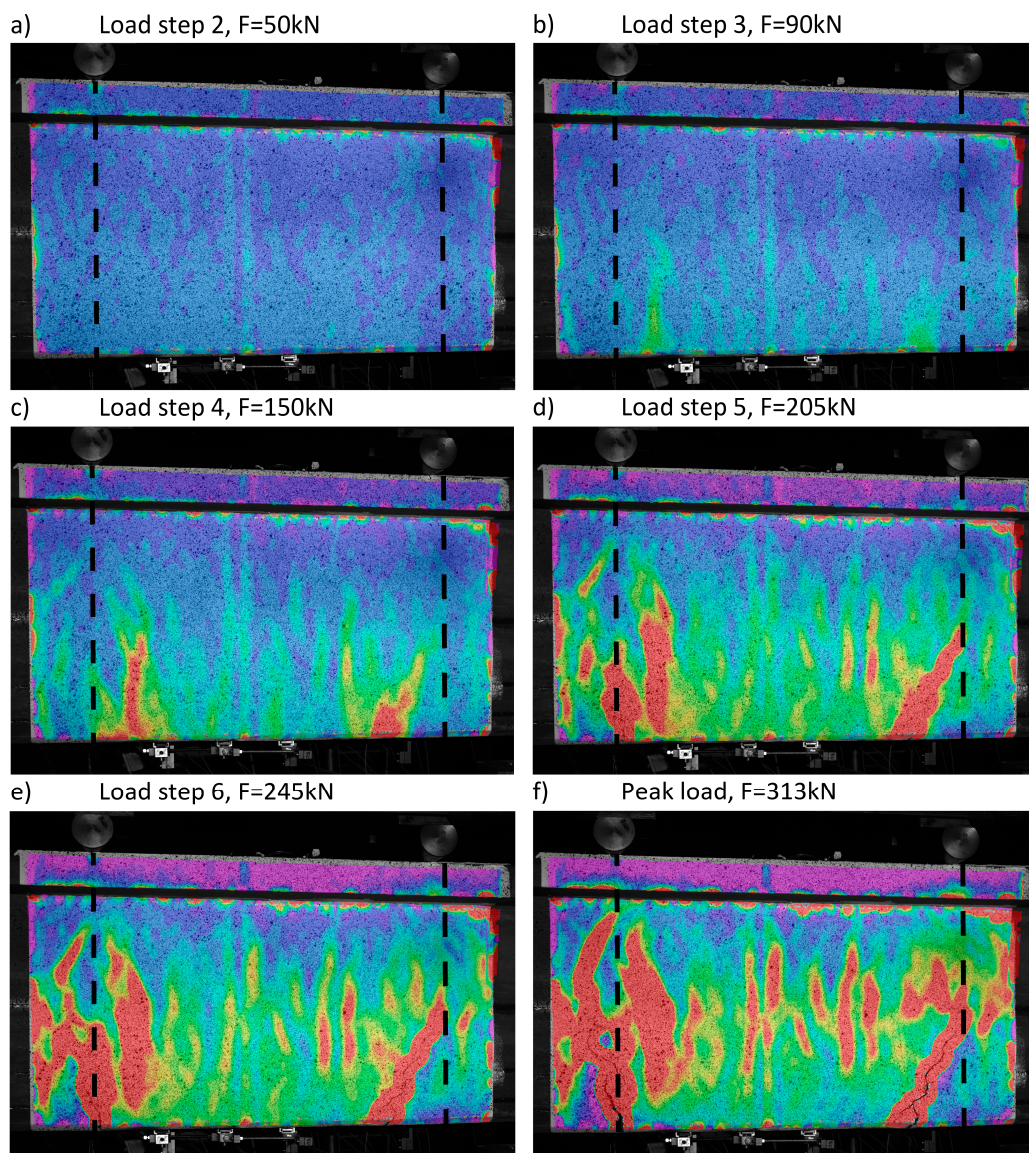
Figure 9. Strain distribution obtained with DIC for different load steps: (a) LS2, (b) LS3, (c) LS4, (d) LS5, (e) LS6, (f) Peak load; ϵ_{xx} with scale as in Figure 8; the constant bending moment zone is marked with dashed lines.

Figure 9 presents the horizontal (ϵ_{xx}) strain distribution measured with DIC at different load steps (LS), marked in Figure 7. The color scale is the same as presented in Figure 8. LS 1 is not shown since mostly the noise is registered. At load step 2, the uniform elastic strains are registered. At LS 3, strain

peaks are observed due to the distributed microcracking of UHPFRC in strain-hardening. They are more pronounced in two weak spots at around -0.25 m and $+0.25$ m (Figure 9b). While the microcracks keep growing and propagating, two of them grow faster than others, leading to localization of fictitious cracks (Figure 9c). At LS 5, fictitious Crack 1 develops a second, left branch. This could be due to the first branch reaching a stronger area with higher concentration of steel fibers (Figure 9d). Simultaneously, fictitious Crack No. 2 keeps propagating on the right side. At LS 6, the fictitious cracks are clearly visible to the naked eye (Figure 9e). As the fibers bridge these macrocracks, the overall response of the beam remains in the hardening domain. When the beam reaches the peak resistance with a force load of 313 kN, the fictitious cracks reach the level of the reinforcement bar (see Figure 9f). In their bottom part, they transmit hardly any stress due to the large opening and advanced fiber pullout. This is why the bottom part of the beam between the fictitious cracks is almost unloaded. The highest strains are present at the level of the reinforcement bar. After this stage, due to transformation of the fictitious cracks into real cracks with no stress transfer and reinforcement yielding, the resistance of the beam started to decrease and the test was stopped.

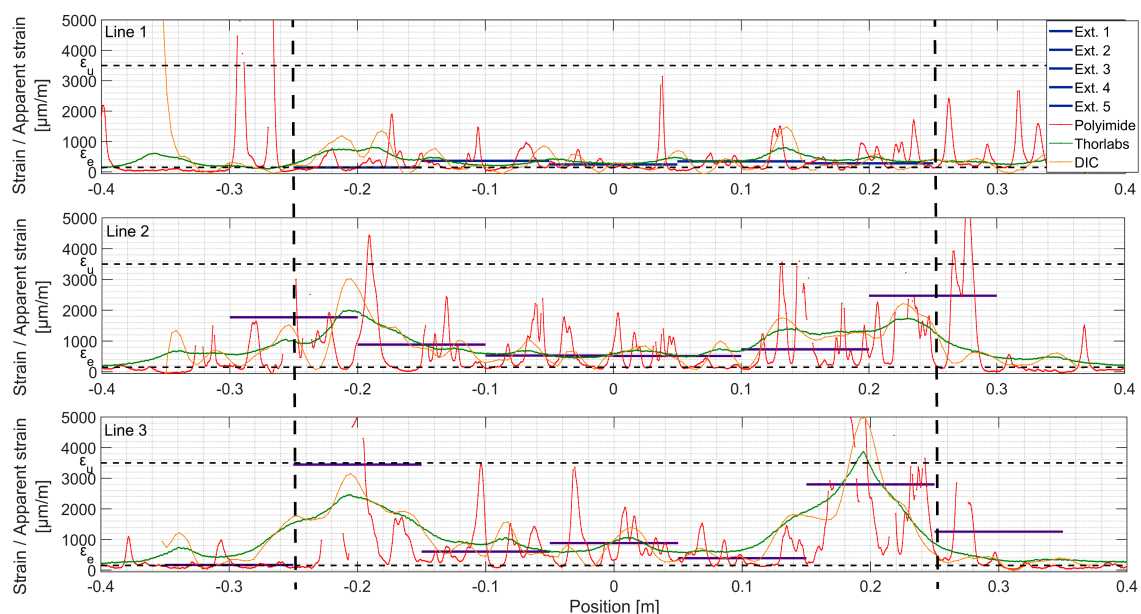
Figure 13. Strains measured with different techniques, load step 4, $F = 150$ kN; the constant bending moment zone is marked with dashed lines.

At LS4 (Figure 13), dropout points start to appear at crack locations in Lines 2 and 3 in the DFOs results. These points are dropped out by the spectral shift calculation algorithm due to low

correlation with the reference spectrum. This phenomenon of miscalculated points increases due to rapid variation of strain over the spatial resolution length. For fictitious Crack 1, Line 3, DIC shows three fictitious crack fronts forming at positions: -0.25 , -0.2 and -0.17 m. They all lay within the same extensometer measurement base, and thus, cannot be distinguished with this technique. Additionally, the Thorlabs fiber is arguably not sensitive enough to clearly separate these fronts due to low shear lag parameter λ (Equation (1)). For fictitious Crack 2, Line 3, the apparent strain reaches ϵ_u , exponential shape is being formed in Thorlabs, and UHPFRC enters softening stage. Two other fictitious crack fronts can be noticed with DIC but hardly with Thorlabs. Extensometer of location $[0.05; 0.15]$ m does not show fictitious crack formation, while it is visible in the same position with DIC and Thorlabs fiber. This comes from the nonorthogonality of the crack regarding the beam axis and is confirmed by Polyimide fiber recording only microcracks in the discussed location. On Line 2, localization of fictitious Crack 2 starts being detectable by Thorlabs fiber and DIC.

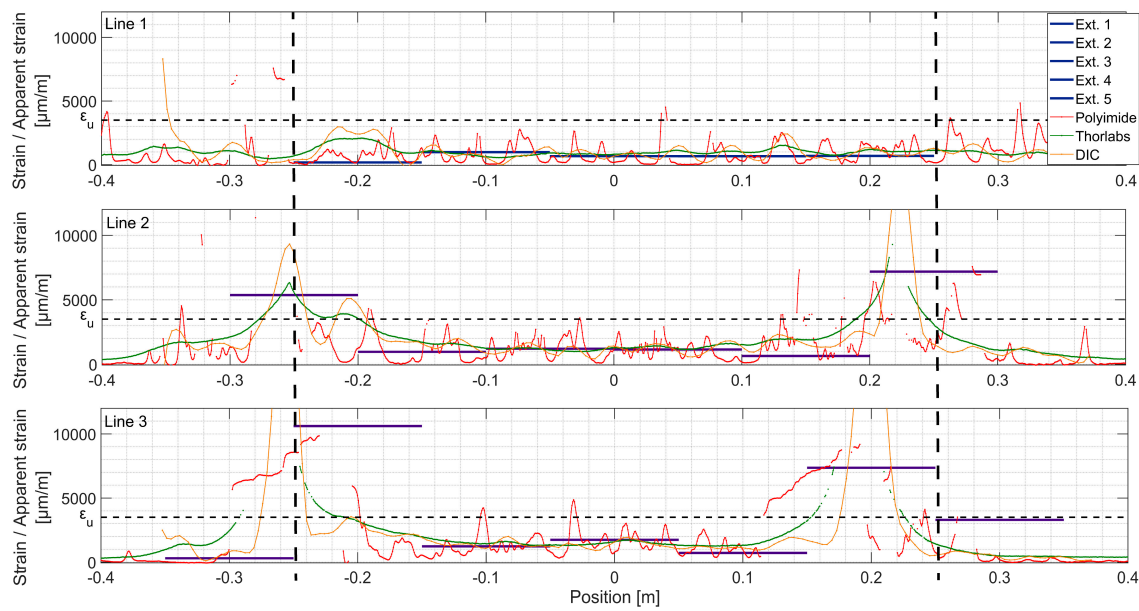
Figure 14. Strains measured with different techniques, load step 5, $F = 205$ kN; the constant bending moment zone is marked with dashed lines.

At LS 5 (Figure 14), both fictitious cracks are clearly formed in Line 3, and UHPFRC is in the softening stage. The DFOs do not work properly in their vicinity anymore. The transversal skewness of fictitious Crack No. 1 can be seen, since the peak of DIC is shifted with respect to the extensometers. Interestingly, it is positioned some 7 cm towards the left regarding the previously observed strain concentration. For both Lines 2 and 3, the clear exponential shapes can be noticed in Thorlabs fiber measurements, but with multiple dropouts. While comparing the measurement Line 1 at the current load step with Line 2 and Line 3 at LS 3, it can be concluded that microcracking is more uniformly spaced for the lines positioned higher on the beam. The reasons might be the nonuniformity of fiber dispersion and discontinuity of strains, both due to the rebar alignment. At this load step, the fictitious cracks are clearly visible to the naked eye, and UHPFRC is in the softening stage (see Figure 9d). The stress transferred by bridging fibers is lower than f_u (see Figure 4), and stress in the neighboring material decreases. Thus, the strain measured at midspan is similar for all the measurement lines.

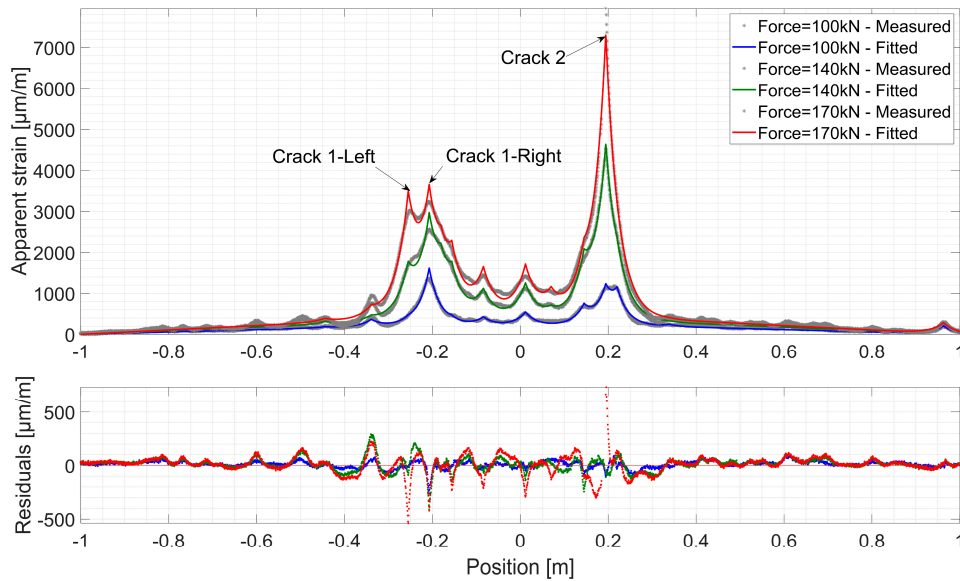
Figure 15. Comparison between the measured and fitted strain profiles and the corresponding residuals over Line 3 of Thorlabs cable.

Figures 15 and 16 present fitted strain profiles to those measured over Line 2 and Line 3 respectively, together with the corresponding residuals for different load levels. A discontinuity propagates in the UHPFRC material through searching the lowest energy path depending on the local fiber content and orientation [51]. Despite the host material's complex microcracking nature, the proposed mechanical

model fits clearly the distributed strain profiles measured by the DFOs system at different levels. Low residual levels are randomly scattered around zero all over the length of FO Line 2 and 3.

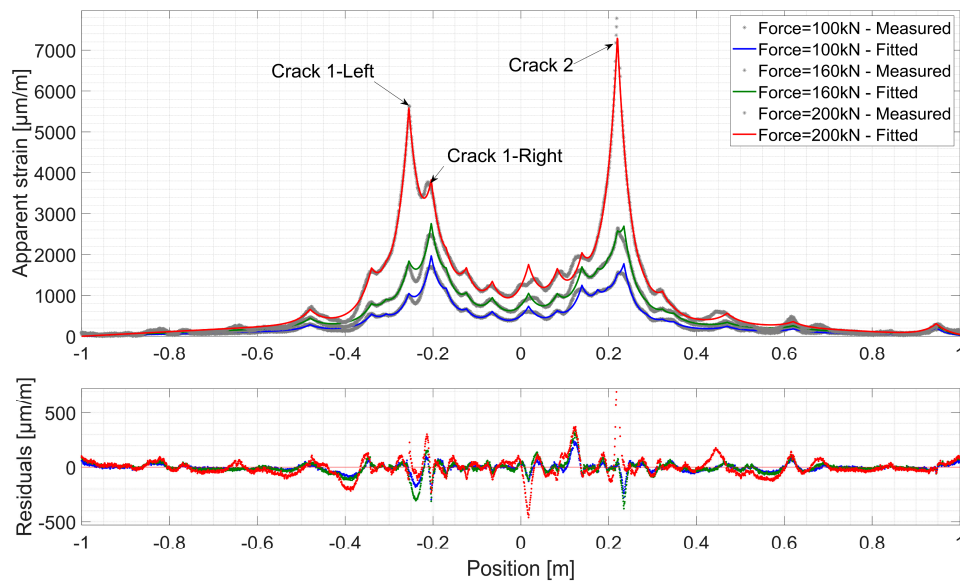
Figure 16. Comparison between the measured and fitted strain profiles and the corresponding residuals over Line 2 of Thorlabs cable.

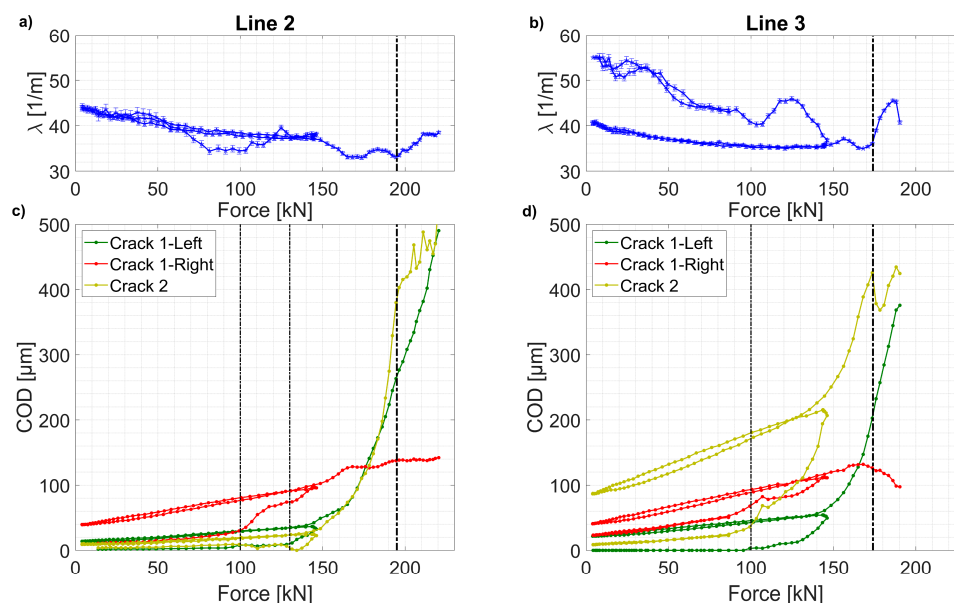
Figure 17. Variation of the estimated COD ((a,b)) and λ ((c,d)) during the test; fictitious crack initiation marked with thin dashed lines; loss of precision marked with thick dashed lines.

Figure 17 shows the estimated strain lag parameter λ as well as the discontinuity openings COD_i of fictitious Cracks 1 and 2, under loading and unloading cycles. For both Line 2 and 3, the estimated strain lag parameter λ varies around 35 m^{-1} in a $\pm 10\%$ interval (Figure 17a,c). Higher λ values can be observed at early stages of the tests. Similar to previous findings on concrete structures [42,53], this variation can be associated with the first stages of UHPFRC cracking behavior, where discontinuities in the cementitious matrix are starting to develop in the so-called fracture process zone, and end up leading to the creation of a microcrack. When most of the matrix discontinuities exceed an estimated opening COD_{min} of $50 \text{ }\mu\text{m}$, the strain lag estimations become stable and consistent around $\lambda \approx 35 \text{ m}^{-1}$. This confirms the assumption of one global strain lag parameter characterizing the Thorlabs fiber/epoxy glue/UHPFRC mechanical response in the presence of a fictitious crack. Lower λ (compared to concrete's surface-mounted fibers (50 m^{-1})) can be attributed to a lower stiffness level at the Epoxy/UHPFRC interface, possibly due to much smaller porosity.

The estimated CODs for discontinuities Cracks 1 and 2 are shown in Figure 17 c and d. At the level of Line 3, the discontinuities Crack 1-right and Crack 2 are formed as microcracks ($<50 \text{ }\mu\text{m}$) and propagate steadily until a force of around 80 kN, where they grow rapidly to form fictitious cracks. At $F = 120 \text{ kN}$, another microcrack grows rapidly to form the fictitious Crack 1-left. This growth leads to a decrease in the growth rate of fictitious Crack 1-right.

Similar development of COD for the three discontinuities can be observed for Line 2, with a delay regarding Line 3 due to its closer position to the neutral beam axis. Akin two-phased growth of COD is observed: stable during microcracking and fast once the fictitious crack is formed in the softening phase.

The growth of COD of fictitious Crack 2 is faster than Crack 1, where the damage development is shared by the two branches. Once it reaches a COD_{max} of $400 \text{ }\mu\text{m}$, unstable growth in estimated COD is observed in both measurement lines. This threshold marks the validity limit of the strain transfer model, where all the layers behave in an elastic manner with no progressive debonding occurring at successive layer interfaces. This phenomenon, equally observed in concrete [41], is pronounced by a change in the exponential form of the strain profiles initiated near the strain peak, and thus, leading to an increase in strain residuals (Figures 15 and 16). Consequently, this leads to a change in the tendency of λ and COD variations due to increased estimation errors.
